**Docket No. 424 – Development and Management Plan Inspection**

The Connecticut Light and Power Company Certificate of Environmental Compatibility and Public Need for the Connecticut portion of the Interstate Reliability Project.

**IRP Overhead ROW**

**Interim Week Inspection:**

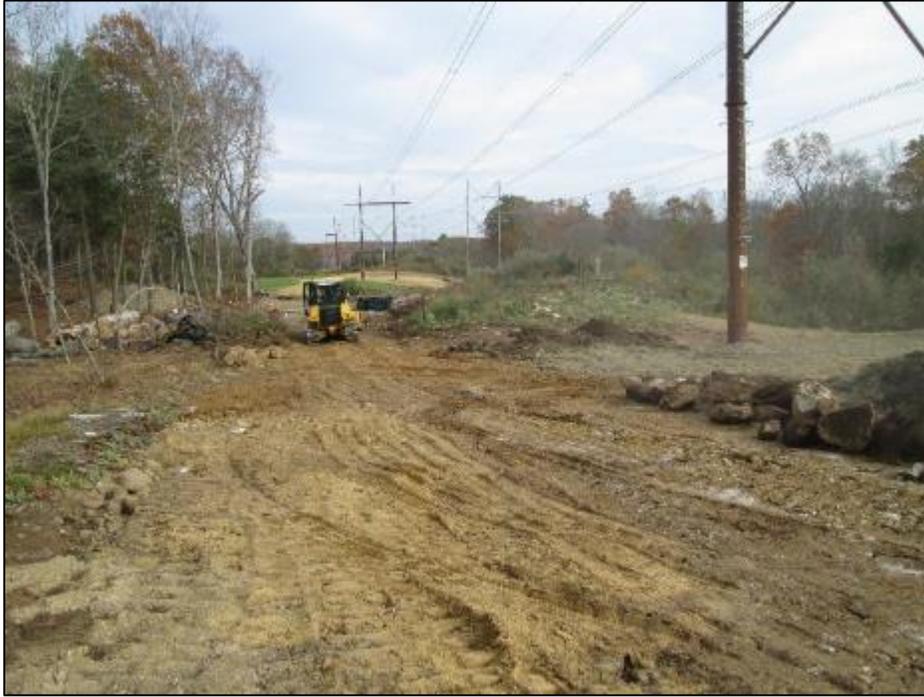
**MS18, Str 92:** Stabilization of exposed topsoil with spread hay, reclamation and restoration of access road down-line of Str 92. (Photo 1 & 2)

- It appears that all work at CSSS is complete. Switching to monthly inspection routine.
- Drilling operations ongoing at Str 164.
- Str 92: Construction pad 92 has been removed, restored and stabilized with straw mulch to their original, pre-construction grades and slopes. (Photo 1)
- Construction pads for structure assembly and erection that were removed, with their areas restored to original grades and slopes: Str 84-87, 92-100, and 269-270.

Photo #1: Removal of fill and stone at Str 92. (10/28)

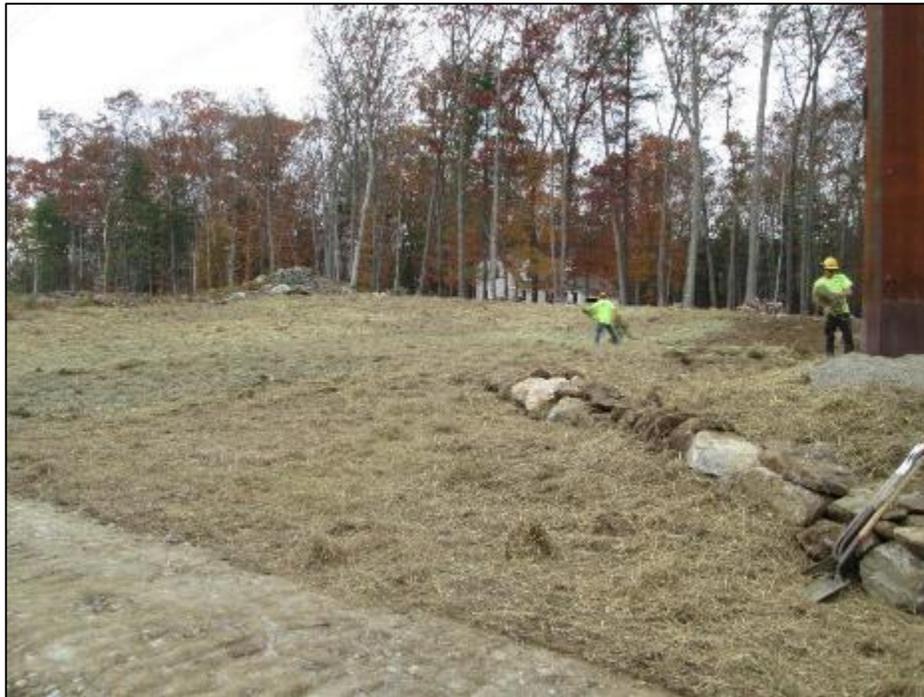
**MS17, Str 89-90:** Stabilization of exposed topsoil with spread hay, reclamation and restoration of access road and pads. (Photo 3)

<b>Str 90:</b> Observed stabilization of exposed topsoil with hay. (Photo 3)	Continue to follow this procedure.	NA
<b>Bi-Week (11/5)</b>	<b>Str 240:</b> Observed plunge pool up-line of Str 240 on edge of access road. (Photo 8)	Continue to follow this procedure.	NA	
		Continue to follow this procedure.	NA	
<b>Inland Wetland and Watercourse encroachment and mitigation</b>	<b>Interim Week (10/28)</b>	Mat installations in wetland areas are in accordance with the BMP Manual.	Continue to follow this procedure.	NA
	<b>Bi-Week (11/5)</b>	Mat installations in wetland areas are in accordance with the BMP Manual.	Continue to follow this procedure.	NA

- Drilling operations ongoing at Str 220.
- Str 89-90: Construction pad 89 and 90 has been removed, restored and stabilized with straw mulch to their original, pre-construction grades and slopes. (Photo 3)
- Construction pads for structure assembly and erection that were removed, with their areas restored to original grades and slopes: Str 84-87, 89-100, and 269-270.

Photo #3: Stabilization of exposed topsoil with hay at Str 90. (11/5)

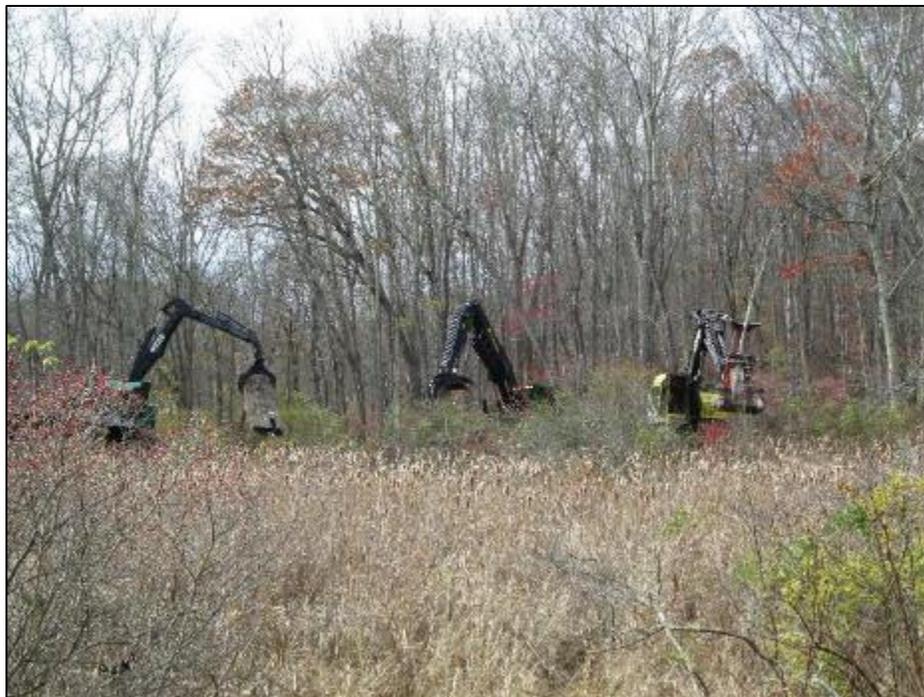
**MS35, Str 182-183:** Clearing operations, feller/buncher utilization of wetland mats. (Photo 4)

<b>Areas of Inspection</b>		<b>Observation:</b>	<b>Recommended Action:</b>	<b>Corrected Action:</b>
<b>Access Roads and Adjacent Roadways</b>	<b>Interim Week (10/28)</b>	Adjacent roadways clear and free of sediment at all visited sites.	Continue to follow this procedure.	NA
	<b>Bi-Week (11/5)</b>	Adjacent roadways clear and free of sediment at all visited sites.	Continue to follow this procedure.	NA
<b>Vegetative Clearing Limits (Including trees to save or danger trees noted.</b>	<b>Interim Week (10/28)</b>	Project clearing observed during inspection appears to be in accordance with D & M plans.  Clearing crews utilizing timber mats in wet areas to prevent unnecessary rutting.	NA  NA	NA  NA
	<b>Bi-Week (11/5)</b>	Project clearing observed during inspection appears to be in accordance with D & M plans.  <b>Str 182-183:</b> Observed Clearing crews utilizing timber mats in wet areas to prevent unnecessary rutting. (Photo 4)	NA  Continue to follow this procedure.	NA  NA

Photo #4: Observed Clearing crews utilizing timber mats in wet areas at Str 183. (11/5)

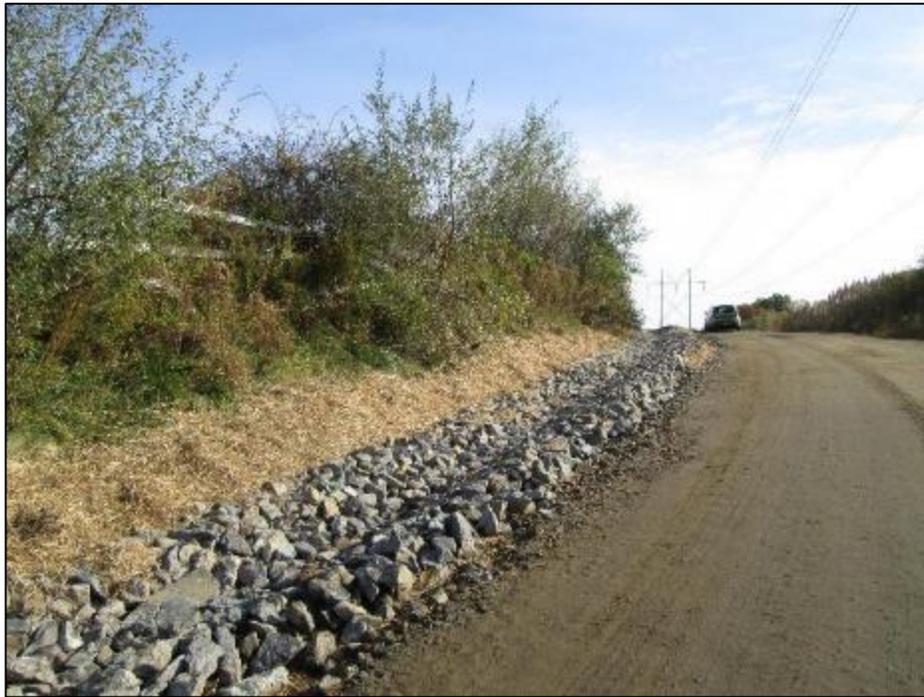
Photo #5: Observed armored swale on edge of access road down-line of Str 243. (10/28)

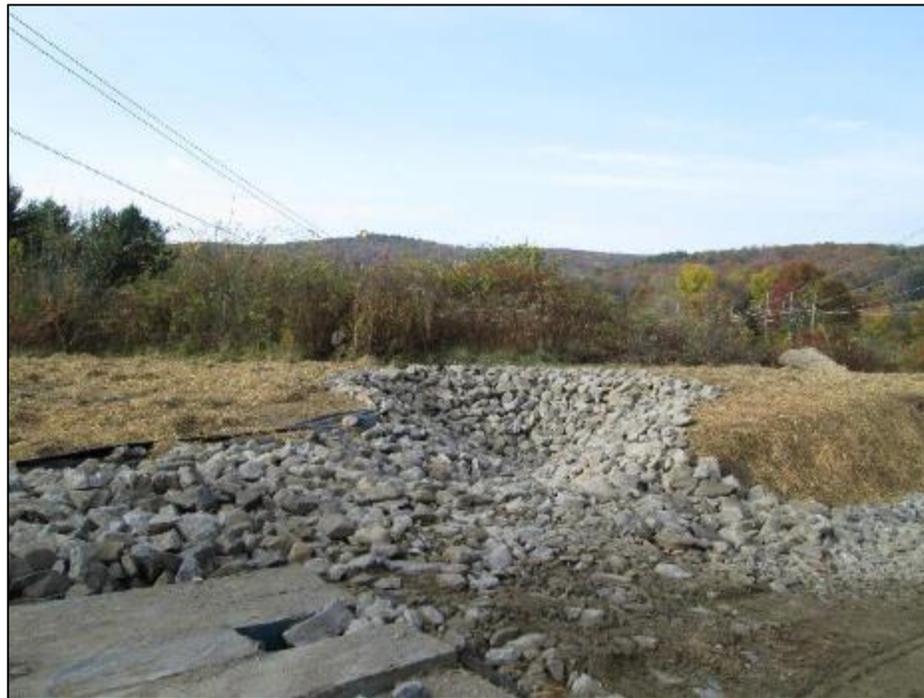
Photo #6: Observed plunge pool on edge of access road down-line of Str 243. (10/28)

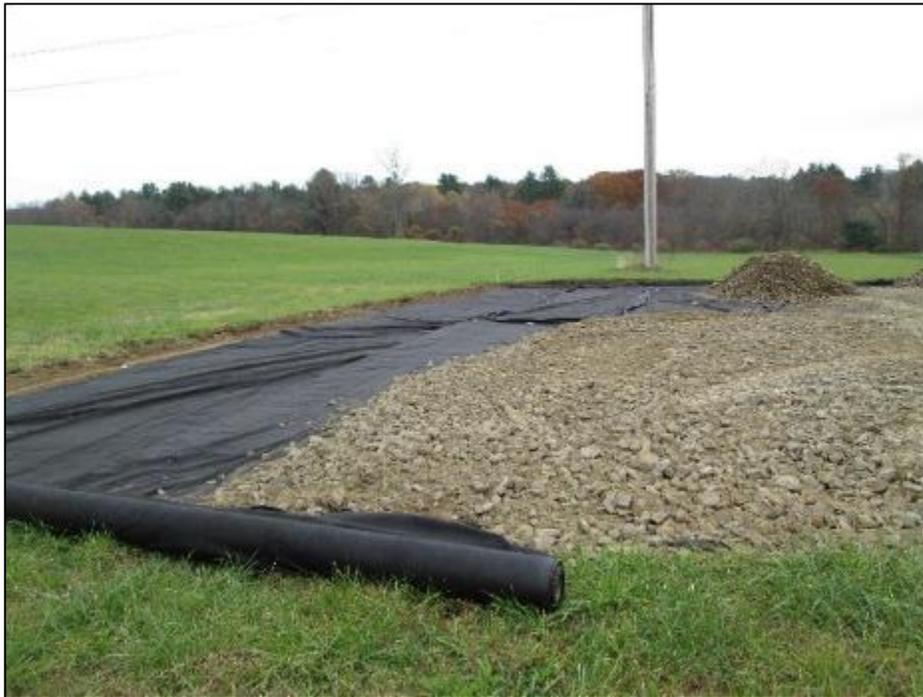
**MS56, Str 283-284:** Delivery of construction materials, rough grading at Str pad 284, placement of filter fabric under stone in farmland protection area, topsoil stockpiled off edge of Str pad 283. (Photo 7)

Photo #7: Observed pad building in agricultural land with filter fabric under stone at Str 283. (11/5)

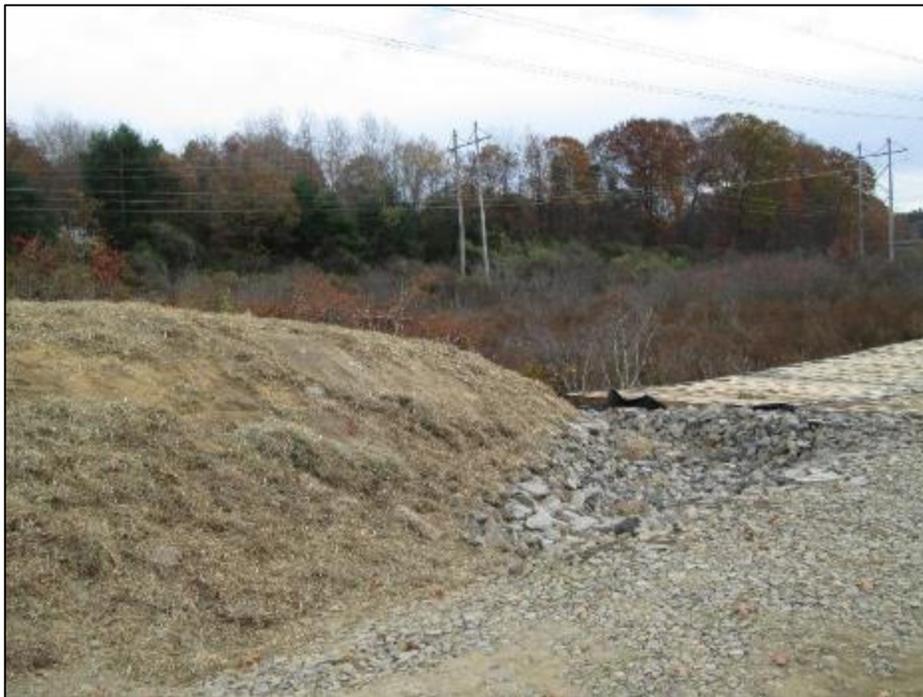
Photo #8: Observed plunge pool on edge of access road up-line of Str 240. (11/5)

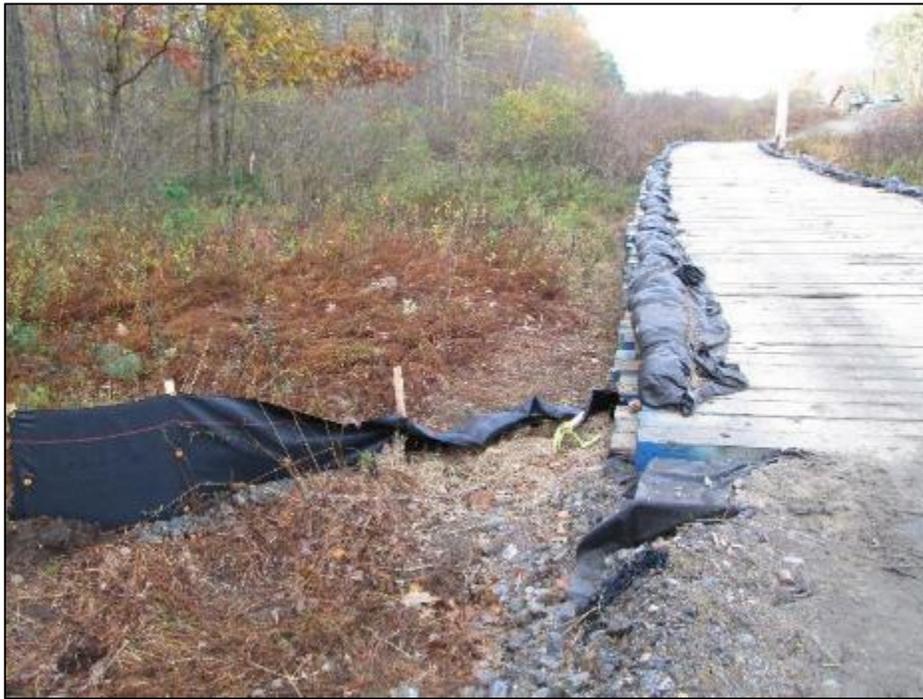
Photo #9: Damaged silt fence up-line of Str 328. (10/28)

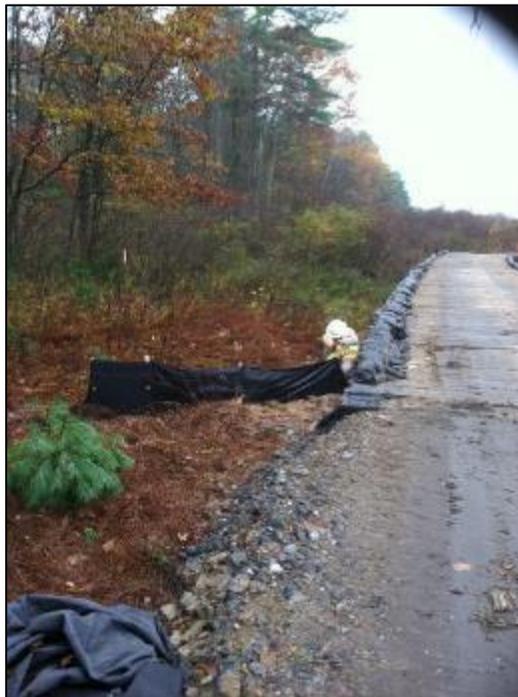
Photo #10: Damaged silt fence up-line of Str 328 being fixed. (10/28)
